# **TESTING OF PROTOTYPE CONDUIT**

**INTERIM REPORT  
TFLRF No. 401**

**U.S. Army TARDEC Fuels and Lubricants Research Facility  
Southwest Research Institute<sup>®</sup> (SwRI<sup>®</sup>)  
San Antonio, TX**

**for  
U.S. Army TARDEC  
Force Projection Technologies  
Warren, Michigan**

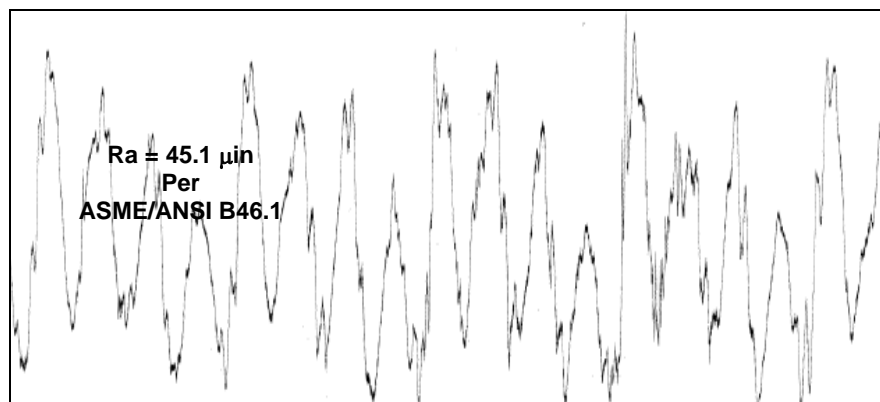
A surface-profiling instrument was used to measure the wavy pattern peak-to-peak height, period, and the surface roughness that is superimposed on the wavy pattern. As shown in Figures 7.1 and 7.2, the surface roughness exhibits a Ra value of 45.4  $\mu\text{inch}$  superimposed on the wavy pattern that exhibits a peak-to-peak height of approximately 0.02 inches. The wave period is about 0.4 inches. If we assumed a sinusoidal shape for the wavy wall (close but not exact), the root-mean-square value (rms) would be 0.707 times the peak height or .00707 inches ( $0.707 \times 0.02/2$ ). For rough order calculations, this would give a hydraulic roughness ( $e/d$ ) for a nominal 6-inch diameter hose of approximately  $0.00707/6 = 0.0012$ , where the surface roughness is denoted by  $e$  and the interior diameter is  $d$ . From previous experience, the author has tested a similar hose and has found that the wavy wall roughness controls the pressure drop and not the surface roughness superimposed on the wavy wall.

**Figure 7.2 - Surface Roughness Profile (Superimposed on Wave Form of Fig. 7.1)**

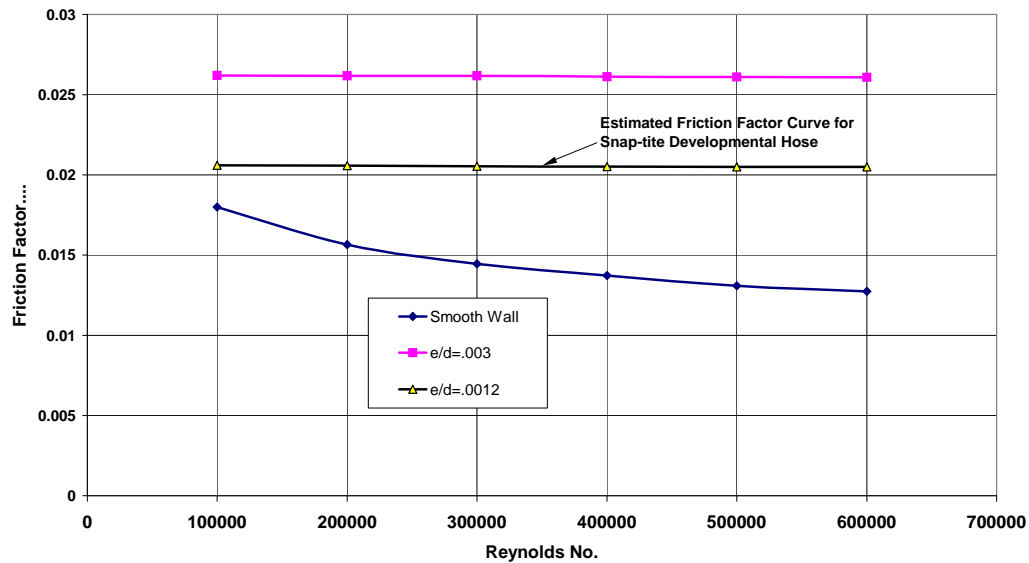
The Colebrook Equation may be used to calculate friction factor, and for a surface roughness of 0.0012, it is found that the friction factor equals 0.02055 over the range of Reynolds Number from 100,000 to 600,000. See Figure 7.3.

**Figure 7.3 - Estimated Friction Factor for Snap-tite Developmental Hose (6 inch Diameter)**

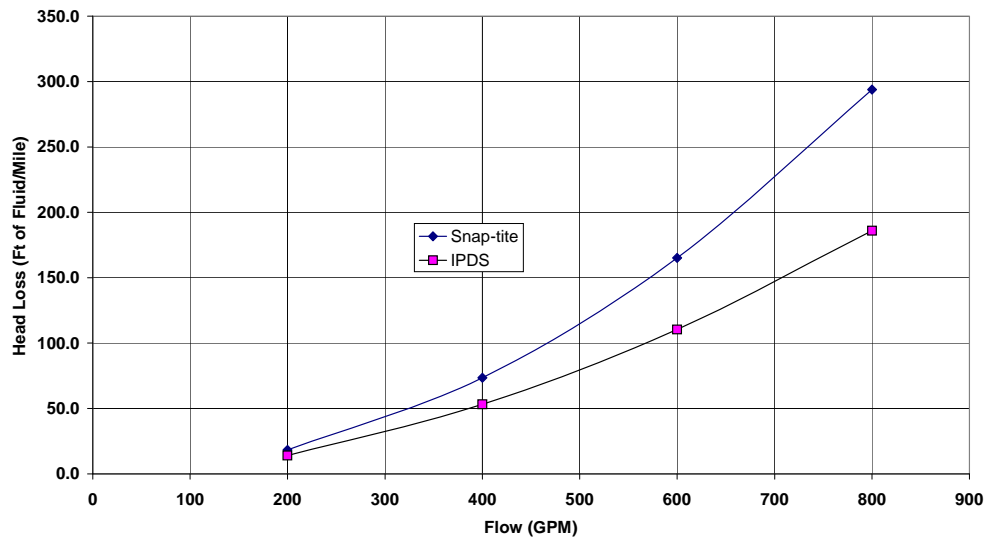
The estimated pressure drop per mile at varying flow rates for the Snap-tite developmental hose is presented in Figure 7.4.

**Figure 7.4 - Estimated Pressure Drop of Snap-tite Hose Compared to IPDS 6-inch Piping**

For comparison, the pressure drop per mile of smooth wall IPDS piping is also shown in Figure 7.4 where it can be seen that the Snap-tite hose exhibits about 50% higher drop as compared to the IPDS piping. The Snap-tite pressure drop could be higher because losses in the couplings have been neglected (although they are expected to be small) and it may be possible

for the hose to induce swirl into the fluid by the apparent swirling pattern created by the weave that is impressed through the interior wall. From the author's experience, this pressure drop is in line with similar rough wall hoses. It is cautioned that these estimates are numerically based and it is highly recommended to conduct flow testing for more precise pressure drop predictions.
